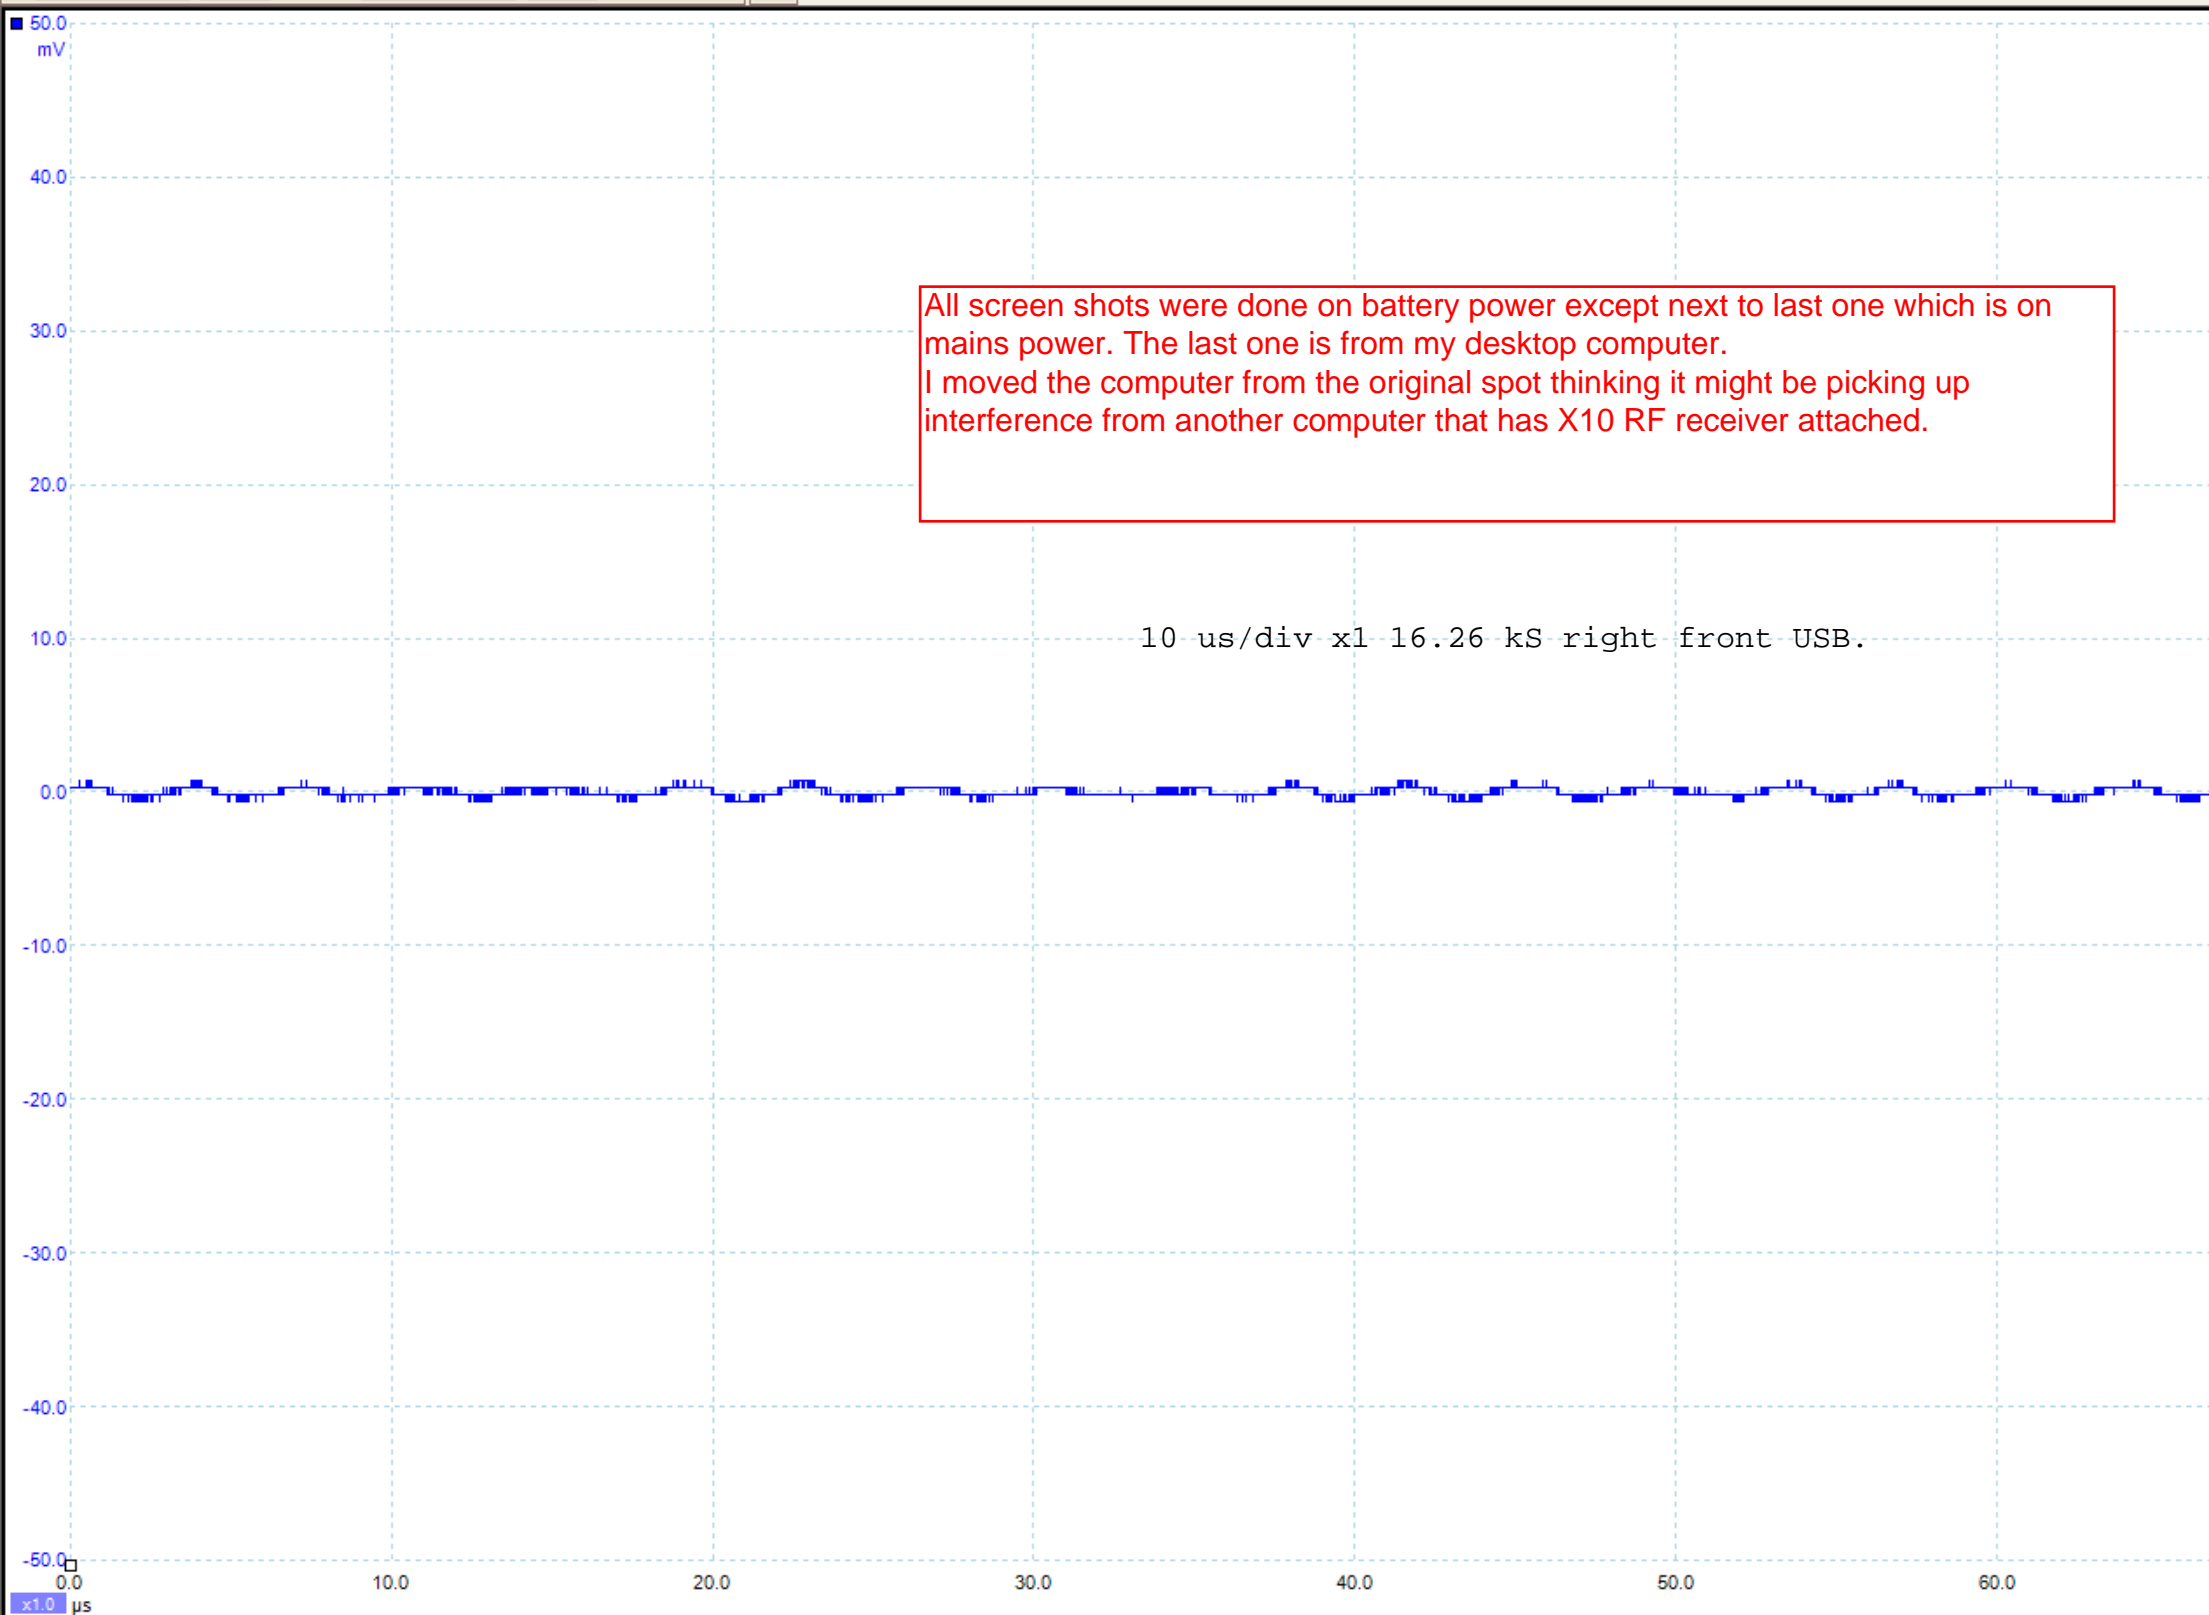
10 us/div x1 16.26 kS right front USB.

All screen shots were done on battery power except next to last one which is on mains power. The last one is from my desktop computer. I moved the computer from the original spot thinking it might be picking up interference from another computer that has X10 RF receiver attached.
